Abstract

The Multy Purpose Detector (MPD) is constructing to study the properties of the hot and dense matter created in heavy-ion collisions in the energy range of 4-11 A*GeV where the maximum baryonic density is expected. Crucial detector in the new experimental setup is a large-sized barrel electromagnetic calorimeter (ECal), designed for precise spatial and energy measurements for photons and electrons. Taking into account the requirements of high energy resolution, dense active medium with the small Moliere radius and high segmentation of ECal, the Shashlyk-type electromagnetic calorimeter with projective geometry has been selected. The mass production of ECal modules has been started. In this talk, we report about methods and technologies for the quality control of ECal modules and their components.

Ecal MPD Overview

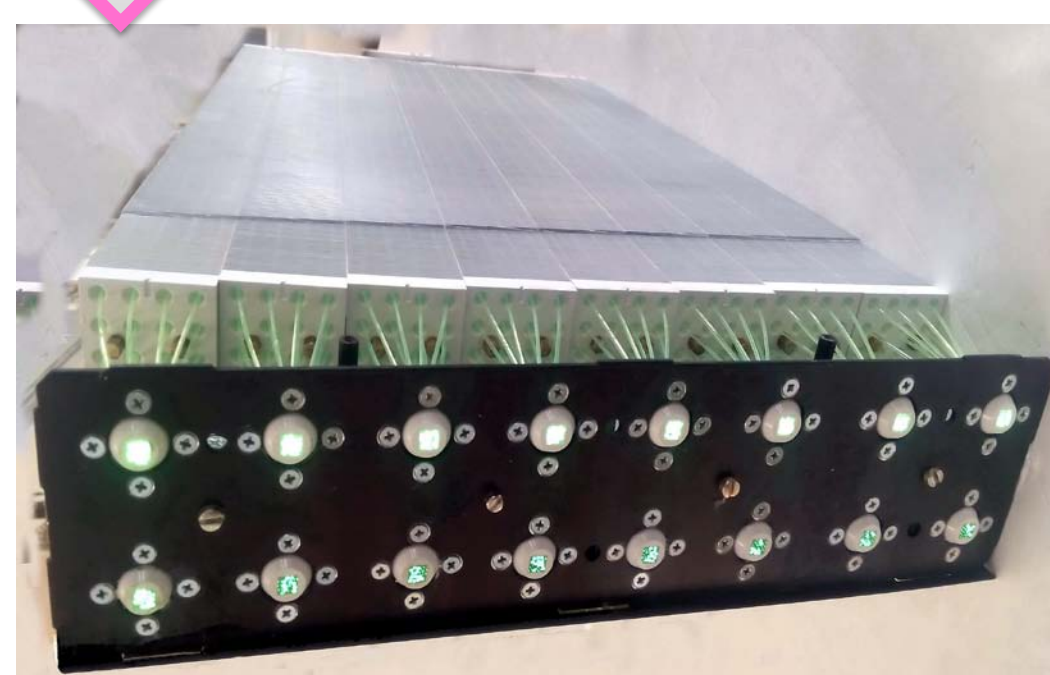
One of the first mass production ECal modules (16 towers)

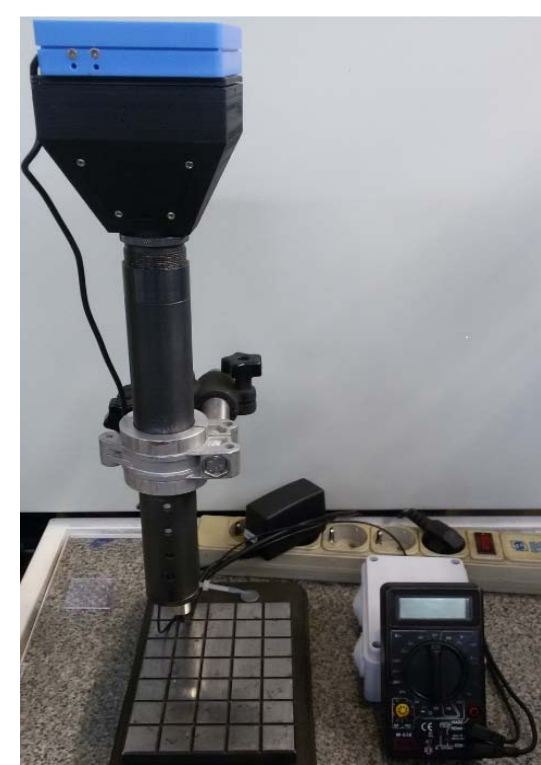
- Quality of Sc tiles is controlled with a spectrophotometer and with a special test bench by comparison light yields from the tested Sc tiles and a reference tile on the LED or with radioactive source. Achieved accuracy is better than 5%
- The thickness of Pb plates is controlled by measuring the thickness at 8 points along the edge and centre of plate before coating by reflector and after the coating procedure
- The size of each tower is controlled by the Mistral 100707 three-axis machine with an accuracy of 4.5 microns after milling to achieve projective geometry

The towers are controlled by the measuring light yield during the longitudinal scan with β -radioactive source

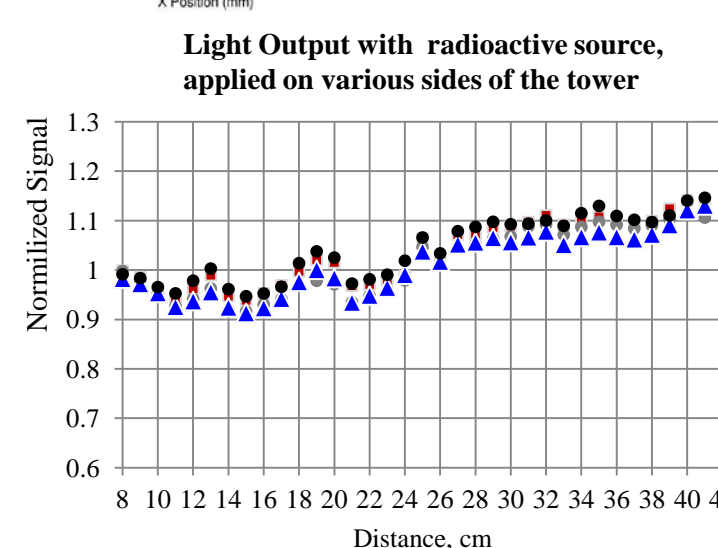
Longitudinal 1 cm scan for first preproduction tower prototype (220 layers) with radioactive source applied from different sides of unmilled tower. These results show the same trend that give us a signal that the quality control methodology was working properly. Heterogeneity is explained by not perfect first samples of scintillator tiles and absorption lengths of fibers.

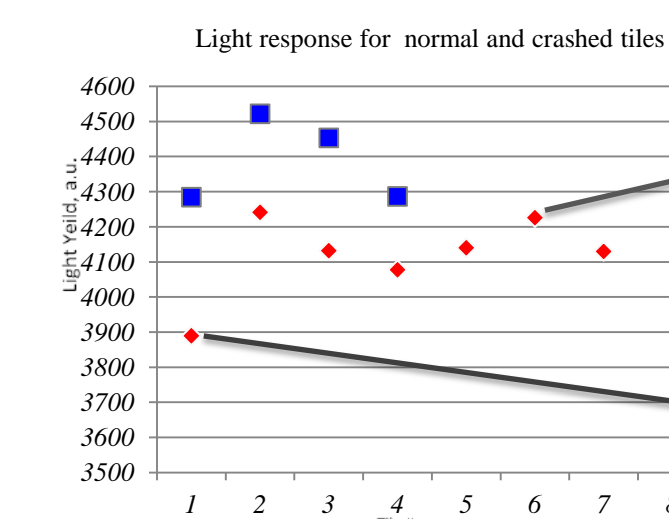
The result of special crash test is shown in the left picture. Blue points corresponds to light response for normal tiles, red points to light response for broken tiles due to overpressure (picture of the tile #9 is in the top right, corresponded red points #6 in the chart) or overpressure plus glue between Sc and Pb plates (picture of the tile #4 is in bottom right, corresponded red point #1). The degradation in the light output for broken tiles in the worst case is less than 10% compared to

conventional tiles. This test demonstrated if something happens with few tiles during assembly it is not as bad as it seems. The leakage of glue is more dangerous than cracks also.
